# HAZARD ALERT

## Four Paper Workers Burned Chemically and Thermally Due to a Pinch Valve Internal Rubber Liner Failure

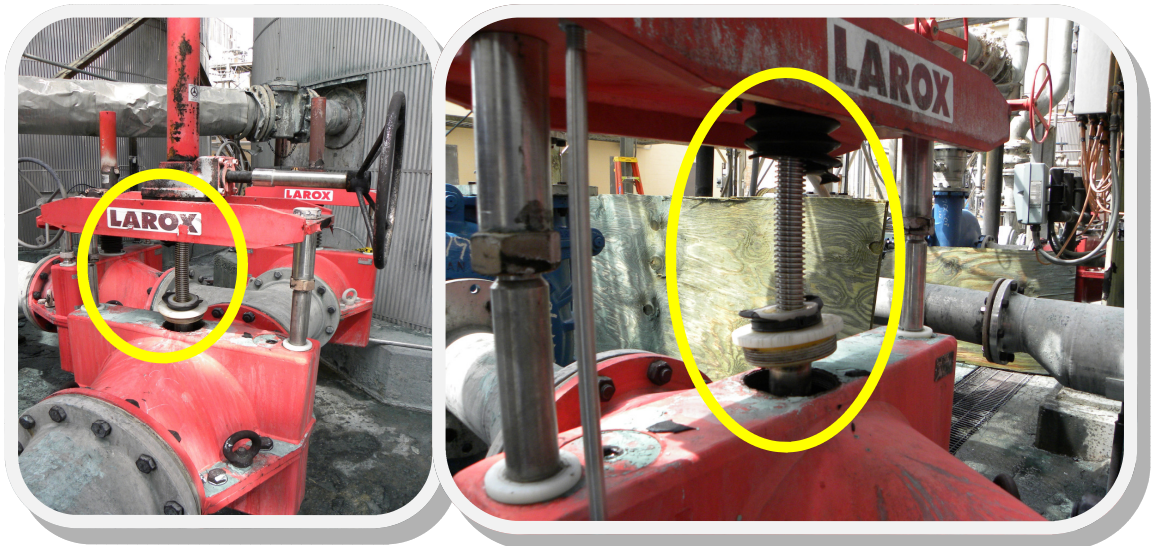
The four workers were burned by white liquor escaping from a 12-inch pinch valve (enclosed body) manufactured by “Larox” with an internal “EPDM/B ethylene propylene” liner. The valve, located on the suction side of the white liquor pressure filter supply pumps, unexpectedly released hot (approximately 195 F) white liquor out through the threaded valve stem and bushing after the internal rubber liner failed. White liquor contains sodium hydroxide, a chemical used for cooking wood chips to break the fibers down for pulping operations. It has a PH of approximately 13.2 and is a caustic slurry and muddy liquid that is very abrasive. The crew members were in the process of isolating the white liquor pressure filter supply pumps due to poor flow issues within the system.

- Properly assess all valves’ age and exposures to temperature, chemicals, abrasion and other factors in accordance with a safe operating procedure. Remove valves/internal liners from service as warranted because the enclosed valve body is not rated for system pressure.

- Contact the manufacturer and other end-users regarding a maintenance and inspection program that establishes a work order for liner replacement.
- Implement a comprehensive valve inspection procedure that includes prompt corrective actions to control the hazards identified.

- Develop standard operating procedures that includes signs of valve failure to ensure effective training for operators, maintenance and contractor personnel.

- Ensure all system valves and piping are in proper alignment.
- All valve bushings are properly seated, have good threads and not leaking.
- Valve stems are straight and not bent.

- Develop a valve assembly procedure with manufacturer.
- Insure best practices are followed in valve liner storage.
