HAZARD ALERT

Failure to conduct Management of Change (MOC) leads to fatality

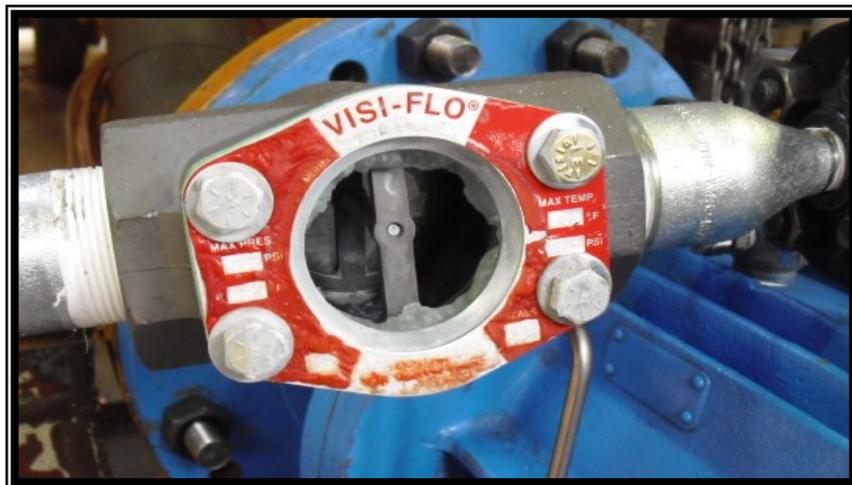
On December 3rd, 2012, a maintenance employee at an oil refinery was fatally injured when a rotameter failed and a mixture of propane and hydrofluoric acid (HF) was released. The rotameter was part of a temporary installation on a pump seal flush line to determine flow to the pump seal.

A temporary line was run from the flush line header to a flare header. A pressure gauge was placed in the line to determine flow. A rotameter was also added for a visual reference. The rotameter was rated for 200 psi but the flush line had an operating pressure of between 260 and 280 psi. The rotameter also had a glass face, which is not compatible with HF service.

No Management of Change (MOC) was conducted prior to the development of this plan or this installation being put into service.

- ◆ For any Process Safety (29 CFR 1910.119) covered facility, prior to any change that is not in kind, you must conduct a Management of Change (MOC)
- ◆ If you are unsure of the need for a MOC, refer to your facility's written plan and 29 CFR 1910.119 (I).
- ◆ Be sure to address the following considerations:
 - The technical basis for the proposed change
 - Impact of change on safety and health
 - Modifications to operating procedures
 - Necessary time period for the change
 - Authorization requirements for the proposed change
- ◆ Employees must be effectively trained in all elements of the Process Safety standard.
