Fatal Incident Involving a Sheeter Machine at a Paper Converting Facility

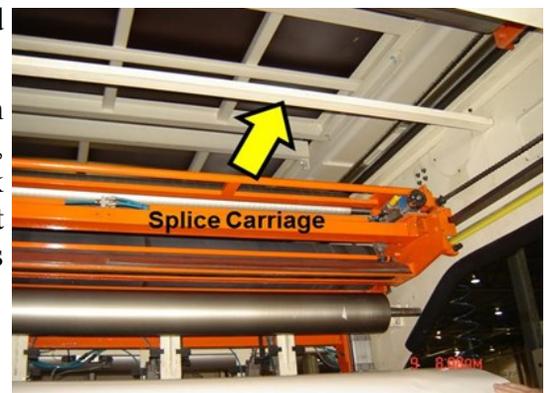
A USW member was fatally injured when he was caught in-between the carriage and a cross-bar of #8 Sheeter's frame during rethreading operations. The sheeter had a "breakout" on the #1 unwind stand. The victim was assisting the operator in rethreading of an existing roll of paper into the sheeter. The operator turned the switch that actuates the carriage movement, attempting to partially move the carriage. Instead, the carriage ran all the way inward and then came backward towards the victim, pinning his chest between the carriage and a horizontal cross-bar of the machine's frame. #8 was a newer sheeter and was built by a different manufacturer than the other three sheeters in the facility. Although #8 is similar to the other sheeters, its splice carriages have a different type of operator control switches.

The splice carriages on #8 are not standardized with the constant pressure or "hold-to-run" type switches as provided on the other three sheeters to "jog" the carriages. The #8 sheeter splice carriages were instead provided with "spring-loaded" switches that require only a momentary contact or "trip" to move the carriage. These switches, once activated, would cause the carriage to automatically travel at full speed to one end of its track or the other. The only way to jog or move the carriage in increments is to rotate the switch in the desired direction of travel and then quickly turn it again in that same direction to make it stop. If the switch was turned in the opposite direction, as would seem logical to reverse the carriage or "stop" it, the carriage would merely continue to travel to the end of its track. The operator, having not worked on #8 before and unaware of this design flaw, tried (with heavy force on the switch) to 'reverse' the carriage or 'stop' it by turning the switch in the opposite direction. This broke the face of the switch completely off, but did nothing to stop the motion of the carriage, which continued to travel. It ultimately pinned the victim between the carriage and the cross-bar of the frame. Machine safeguarding was not provided in the immediate area where both employees were working and emergency stop button(s)/rope(s) were not accessible.

Each shift did rethreading differently. Some crews ran the carriage completely inboard to the end of its track, some ran it all the way to the outboard end of its track and some preferred to move or jog the carriage to a point along the length of its track. Safe Operating Procedures were not developed for rethreading operations.

- Work with the machine manufacturer to relocate the cross-bar to eliminate the pinch point between the carriage and the cross-bar.
- The machine manufacturer must issue Product and Safety Notices with Mandatory Actions (#8 sheeter was made by GOHA – Model GS/B Number 101).

- Remove "trip" type switches and install constant pressure type or "hold-to-run" switches. This will allow the operator to control the 'jog' the carriage into a desired position.

- Develop and document procedures for: rethreading, Lockout/Tagout/Verify – all with input from the shift crews; update training accordingly.
- Improve labeling of operator control board(s) switches.

- Conduct a machine safeguarding assessment survey on all sheeters.
- Provide all workers with a Right-To-Act process (including, but not limited to; procedures to report hazards, refuse unsafe/unhealthy jobs/tasks and shut down any process without the fear of retaliation). All workers shall be trained/retrained annually on the process.
