HAZARD ALERT

Fatal Accidents with Mobile Equipment and Foot Traffic

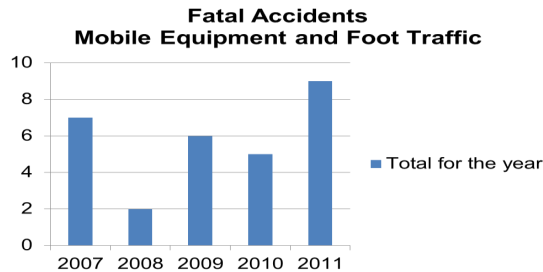
2007 — 7 Fatalities

2008 — 2 Fatalities

2009 — 6 Fatalities

2010 — 5 Fatalities

2011 — 9 Fatalities

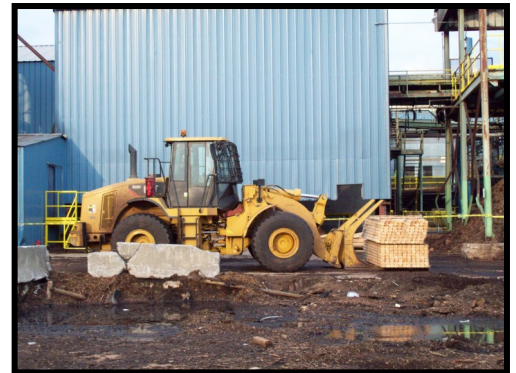
In 2009 a mechanic was fatally injured when he was struck-by a CAT 950H front-end loader. The CAT operator thought he heard someone calling for him while he was driving forward; he then proceeded to drive in reverse to the area where the call may have come from. During this time the mechanic entered the work area, but was not seen by the CAT operator due to the inherent blind spots of the equipment and physical obstructions in the area. Neither employee was trained on the equipment's blind spots and there was no written procedure as to how foot traffic should make contact with the operator.

Recommendations to Prevent Recurrence:

- Apply the Hierarchy of Controls to eliminate/separate mobile equipment from foot traffic. For example: use a different type of truck or conveyors where possible, barrier guards/knock-down markers/designated (painted) walkways with gates, eliminate blind spots, widen passageways, limit material storage height and install proper signage "No Foot Traffic."

- Identify unavoidable blind spots and their distances to assist in designating the right equipment for the task - see NIOSH Highway Work Zone Safety Publication.

- Install and maintain safety devices: backup cameras/sensors/mirrors & alarms that can be heard above ambient noise, install lighting/traffic mirrors, motion activated lights/gates, position co-workers to act as spotters, use/maintain radios and more.

- Ensure that operators, other employees and contractors are adequately trained and evaluated on the specific equipment and operations used at the workplace, including a distance rule and approach procedures to mobile equipment. (The USW provides a wide range of health and safety training including mobile equipment).

- Wear work zone safety clothing that meets ANSI A107
