Fatal Accident with an Unguarded Pneumatic Hand Grinder

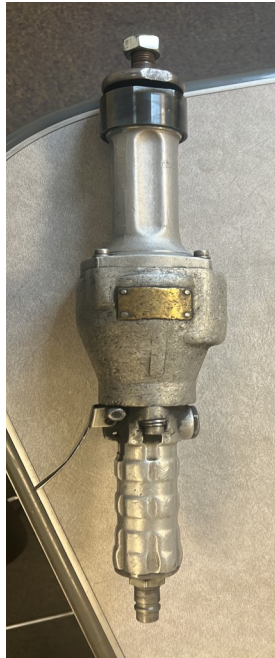
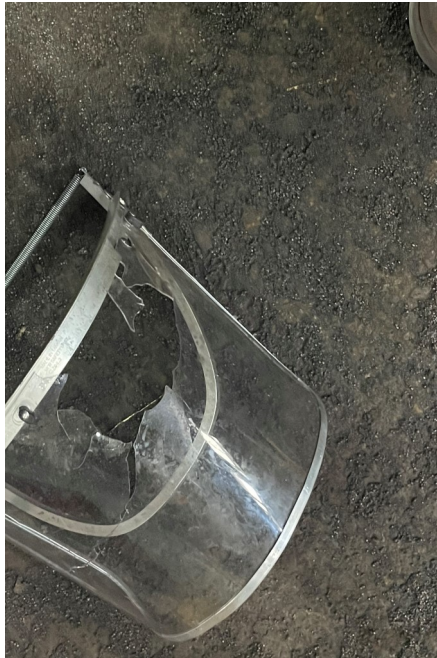
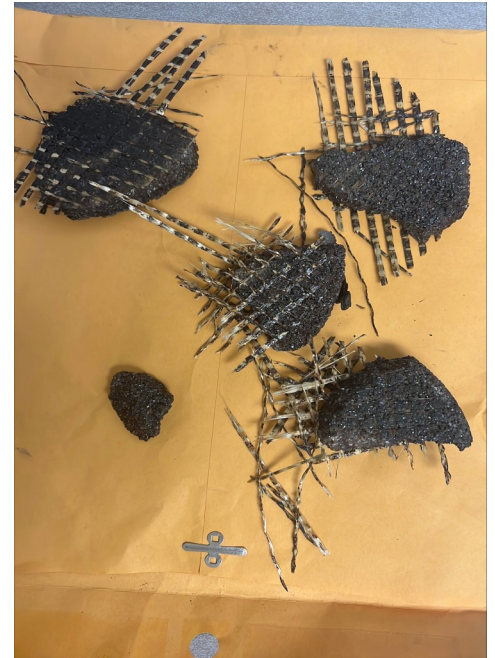
A USW member was working alone performing grinding duties on a cast carbon steel part in a work station at a foundry. While operating an unguarded pneumatic horizontal hand grinder with a 6-inch type 1 snagging wheel, the rotating wheel exploded. The flying wheel fragments struck the operator in the face and neck area causing fatal injuries, even though he was wearing eye and face protection. The equipment involved was a Top Cat 56H Series Horizontal Grinder with a 6-inch DACO 1539SW wheel attached.

- Audit all grinders for compliance per the manufacturer's guidelines and the American National Standards Institute B7.1 Safety Requirements for the Use, Care and Protection of Abrasive Wheels.

- Safety guards of proper design and construction must be maintained or the grinder needs removed from service using a Stop Work Authority process as outlined in the [USW's Bargaining for Stop Work Authority to Prevent Injuries and Save Lives](#).

- Audit all grinders to ensure that spindle does not exceed maximum RPM of grinding wheels.
- Audit handling practices for all grinding wheels to ensure care is exercised to prevent damage.

- Handle and store grinding wheels in safe location not subject to water, solvents, condensation, high humidity or freezing temperature, and related shelf life.

- Establish inspection process for new and existing grinding wheels.
- Train all operators on use, care, mounting, inspection and operation of abrasive grinding wheels and maintaining grinders.
